Failure Analysis of Heavy-Ion-Irradiated Schottky Diodes

Megan C. Casey¹, Jean-Marie Lauenstein¹, Edward P. Wilcox², Alyson D. Topper², Michael J. Campola¹, and Kenneth A. LaBel¹

¹NASA Goddard Space Flight Center, Code 561.4, Greenbelt, MD 20771

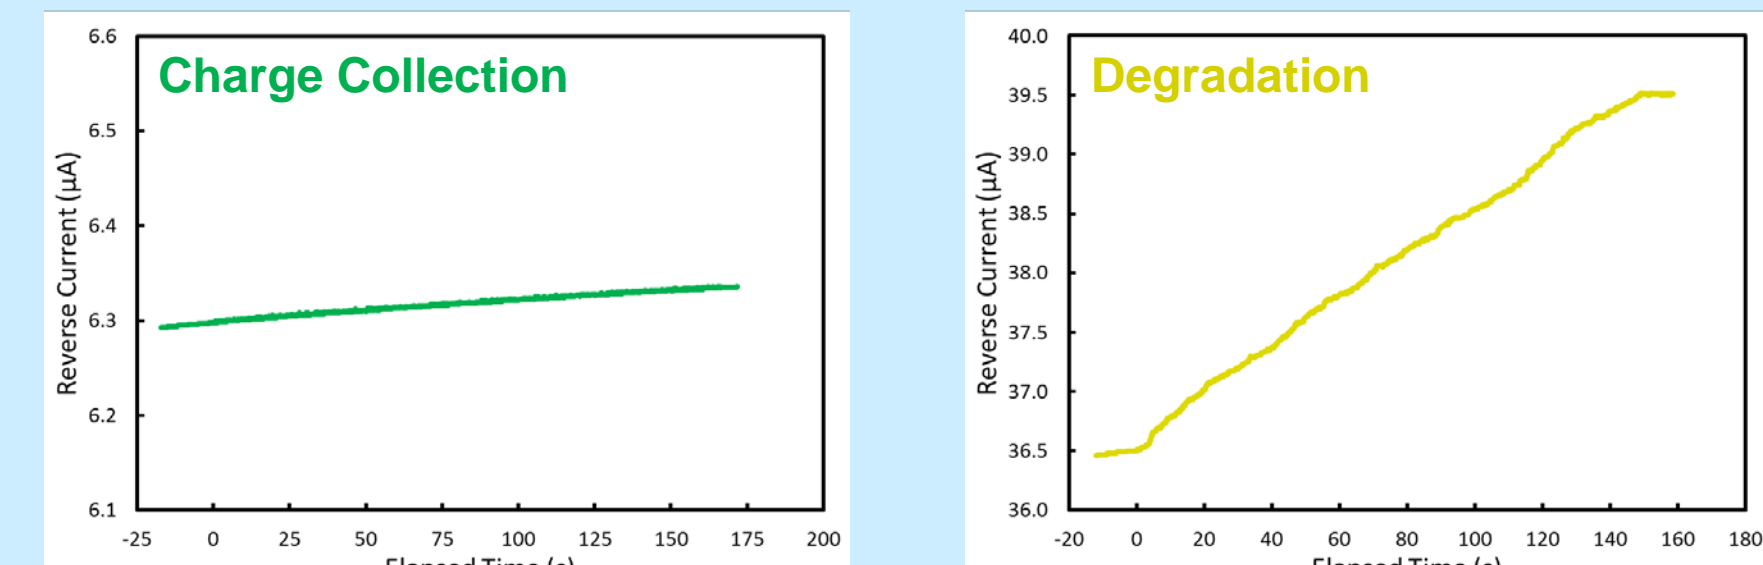
Fig. 1a. Charge collection is observed during the beam run. All post-irradiation parameters were within specification, and this was considered a passing condition.

Fig. 1b. Degradation is observed in the reverse current during the beam run. All post-irradiation parameters were within specification, and this was considered a passing condition.

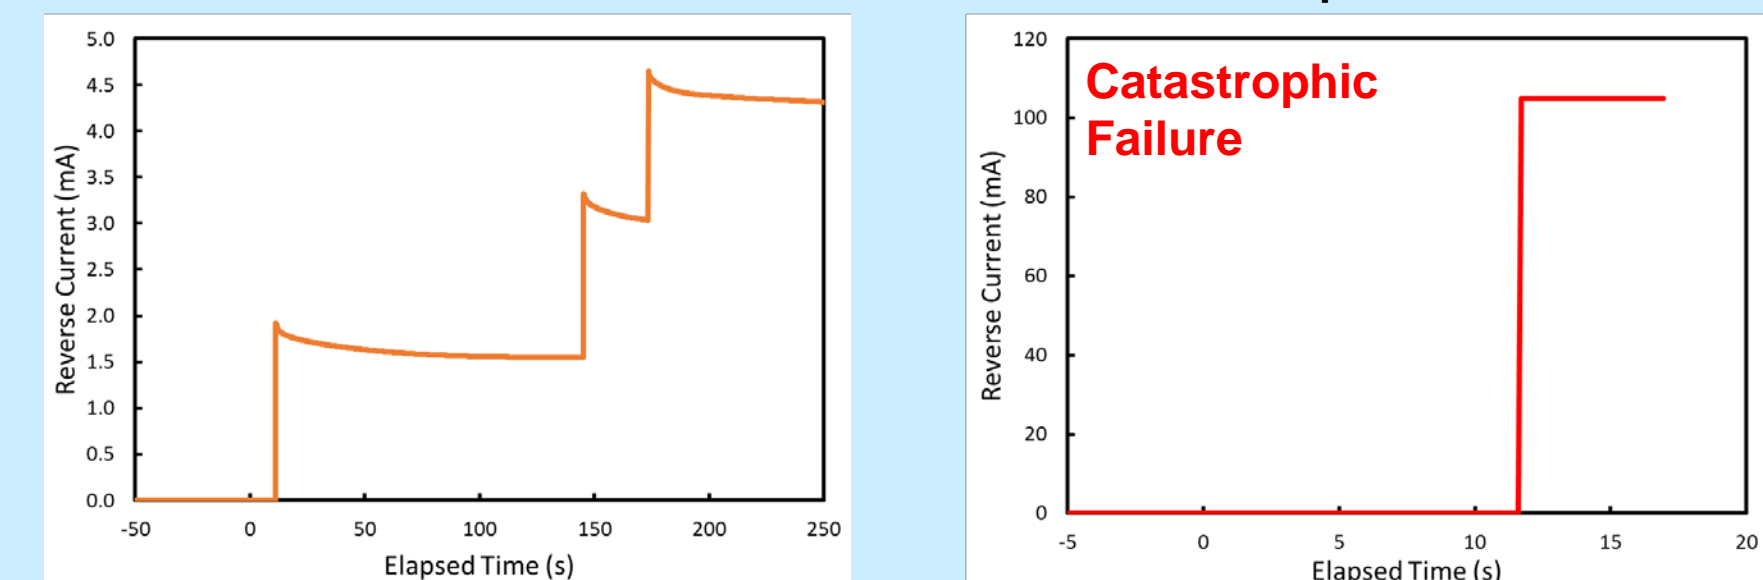
Fig. 1c. Degradation is observed in the reverse current during the beam run. Some or all of the post-irradiation parameters were outside of their specification, and this was considered a failing condition.

Fig. 1d. Catastrophic failure is observed in the reverse current during the beam run. Some or all of the post-irradiation parameters were outside of their specification, and this was considered a failing condition.

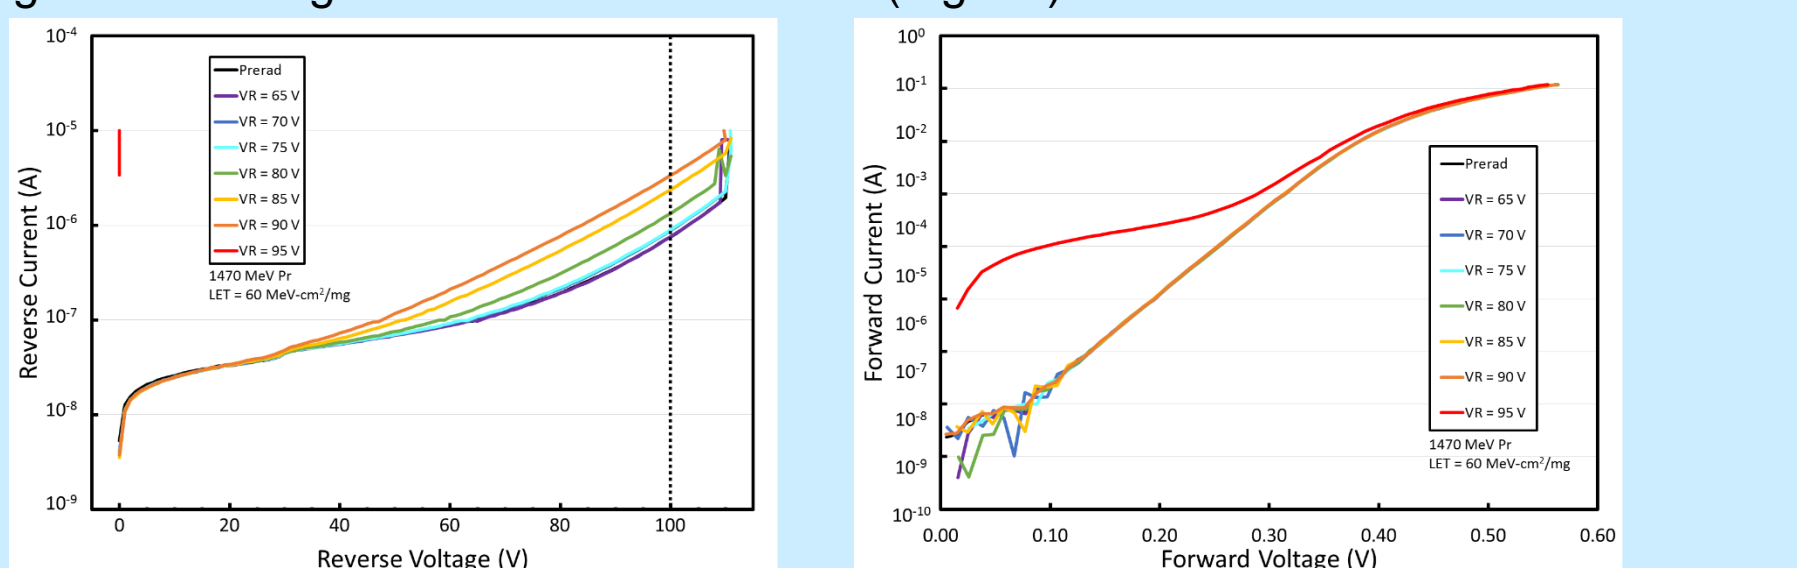
The reverse I-V curve (Fig. 3a) shows that the part was degrading slightly during each run, however, after the 95-V run, I_R exceeded the 10 μ A specification at less than 1 V. There was also a significant change in the forward I-V curve (Fig. 3b) after this run as well.

Fig. 3a. The post-irradiation reverse current as a function of the reverse voltage is shown for each beam run.

Fig. 3b. The post-irradiation forward current as a function of the forward voltage is shown for each beam run.

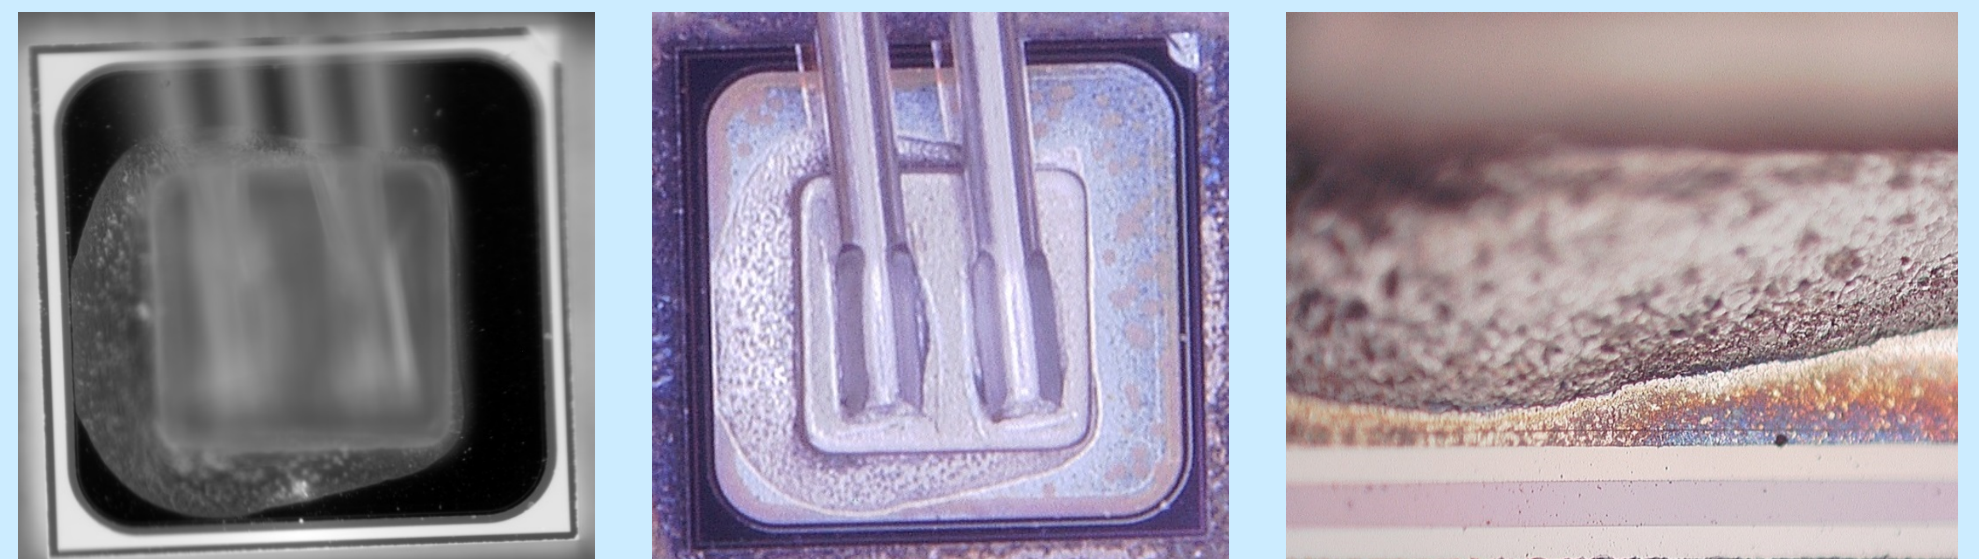
After irradiation, SN5 was examined using an IR camera and pictures were taken with a small voltage applied. Bright white spot (indicating elevated temperature, and shown in Fig. 4a) just below the wirebond contact is the location of the failure. Low-magnification (Fig. 4b) and high-magnification (Fig. 4c) optical images of the surface of the DUT did not show anything unusual at the location identified in the IR image.

Fig. 4a. Thermal image of the irradiated DUT identifies location of failure.

Fig. 4b. The failure location is not visible in the low-magnification optical image of the DUT.

Fig. 4c. The failure location is not visible in the high-magnification optical image of the DUT.

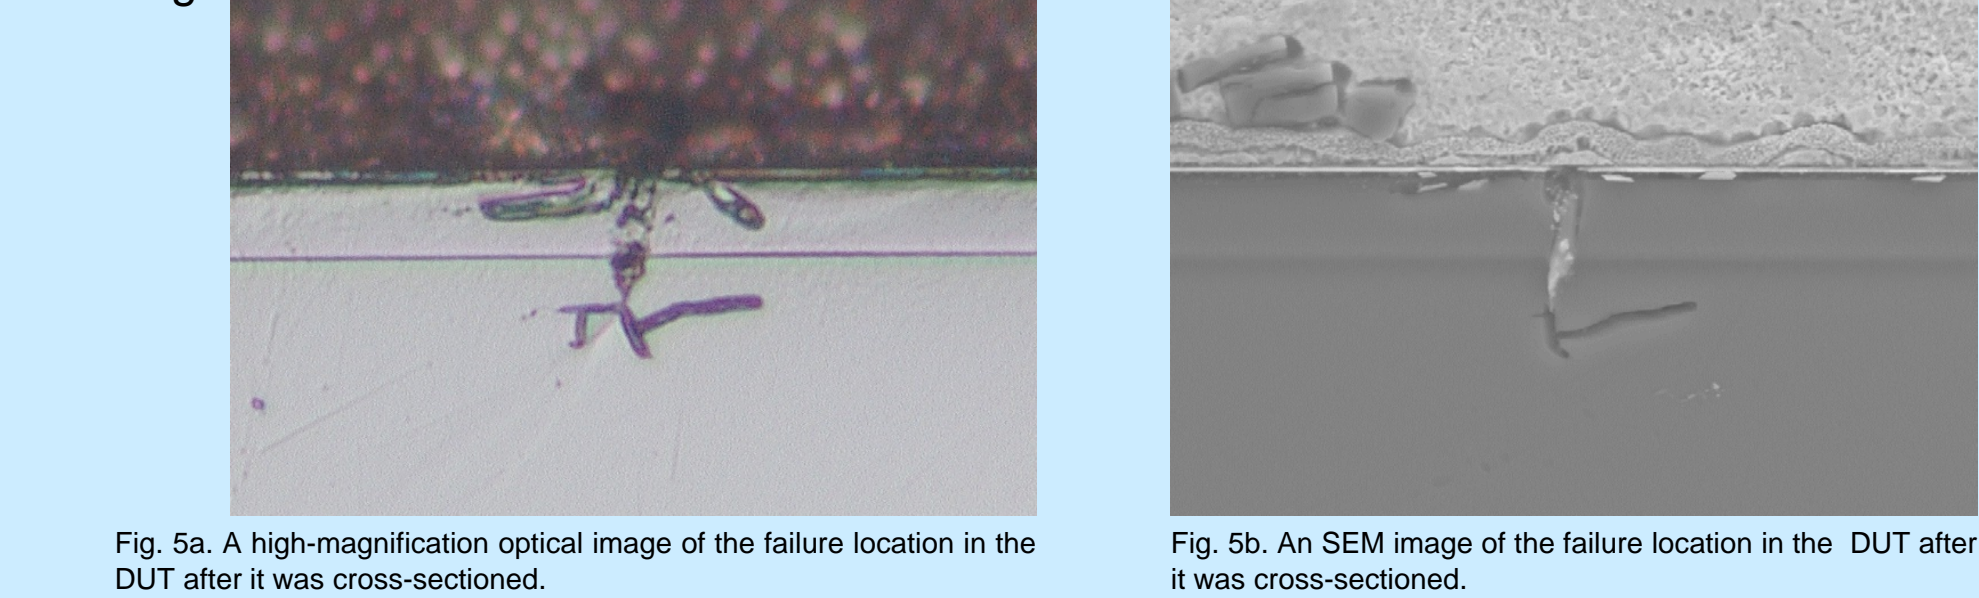
The DUT was then cross-sectioned at the location of the failure identified in the IR image, and then silicon was stained. A high-magnification optical image (Fig. 5a) and a scanning electron microscope (SEM) image (Fig. 5b) of the failure are shown below.

The failure location is clearly observed from the Schottky barrier metal down through the epitaxial layer (epilayer), all the way to the bulk silicon. The extreme heat generated by the single-event strike also resulted in mechanical stress on the die and the subsequent cracking.

Fig. 5a. A high-magnification optical image of the failure location in the DUT after it was cross-sectioned.

Fig. 5b. An SEM image of the failure location in the DUT after it was cross-sectioned.

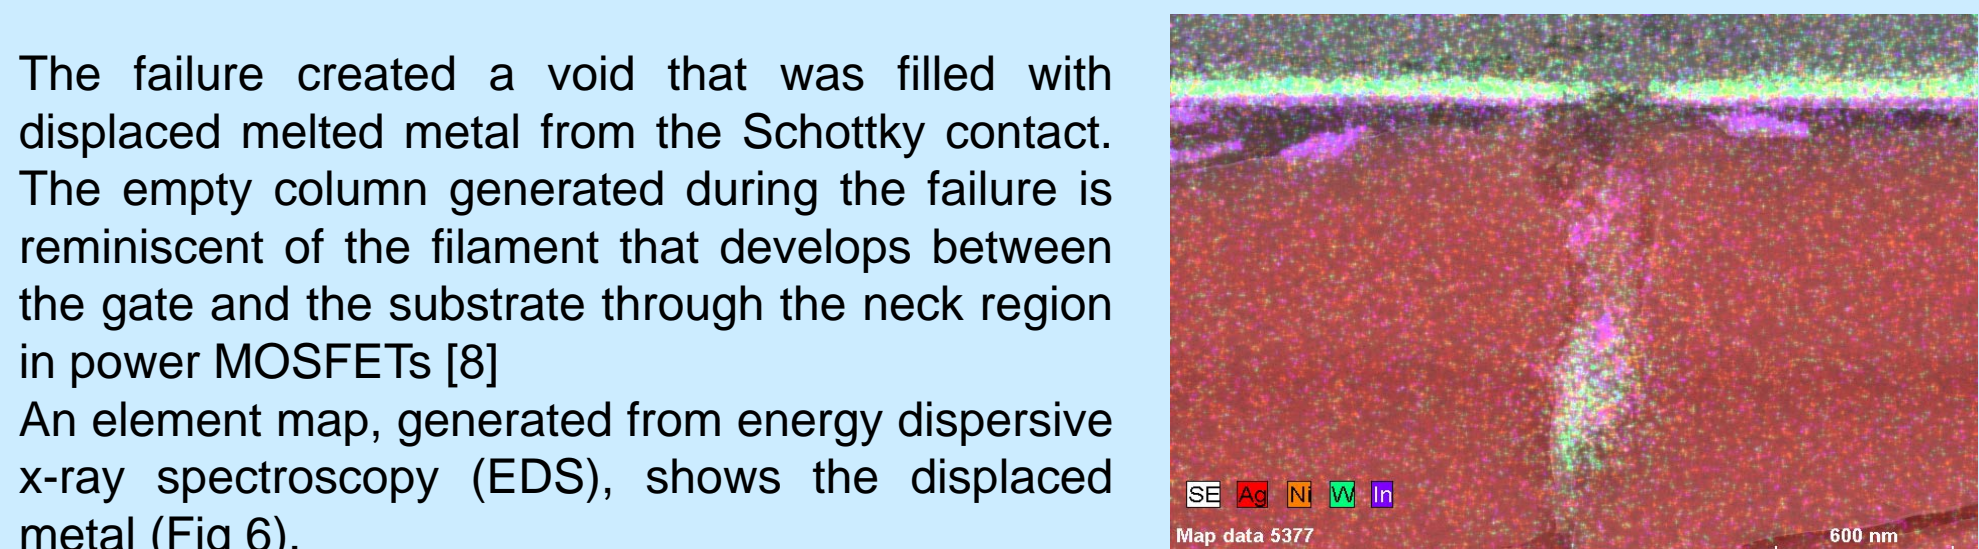
Fig. 6. Element map of the failure location in the DUT generated from EDS.

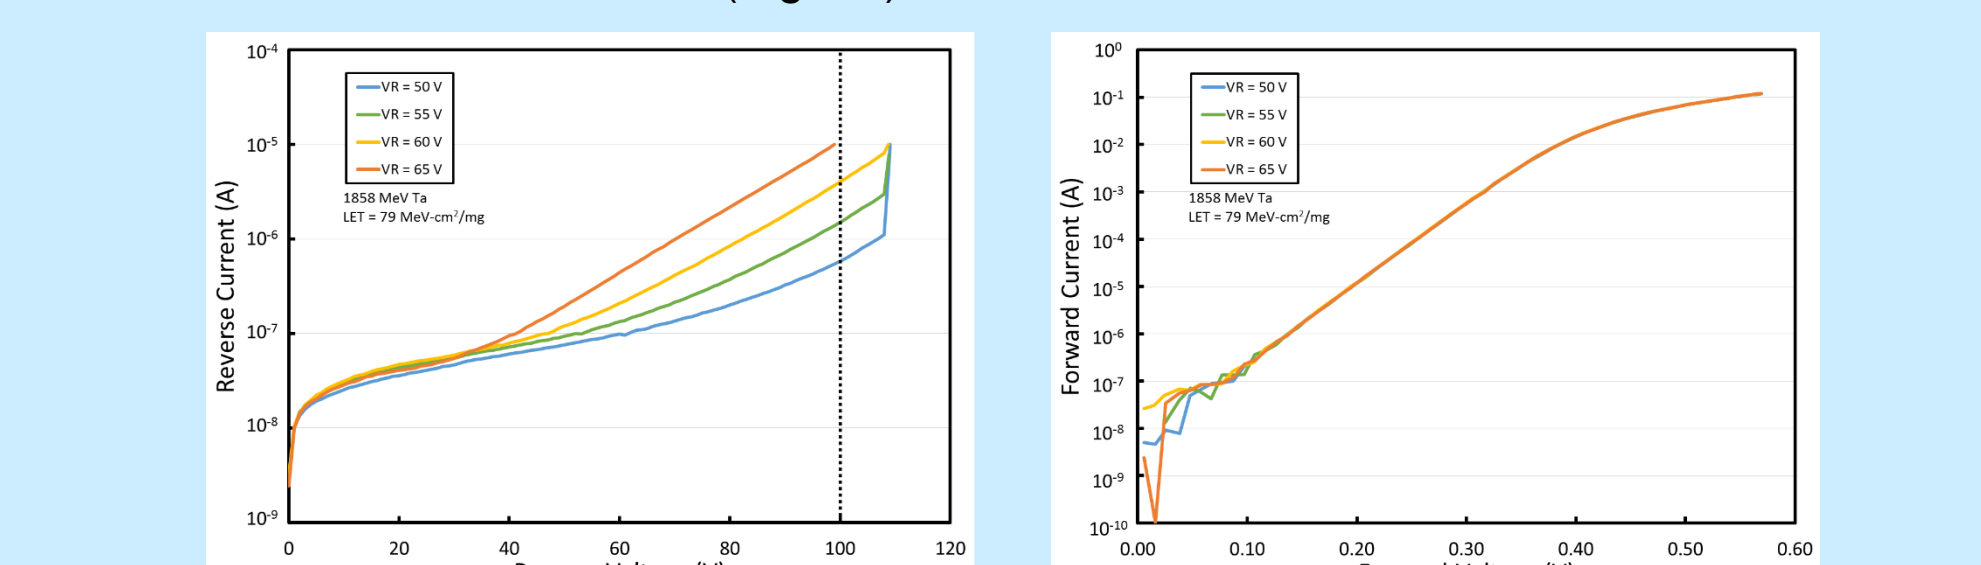
After degradation was observed during the 65-V run, I_R exceeded 10 μ A at less than the minimum rated 100 V (shown in Fig. 8a). No change in the forward I-V curve was observed (Fig. 8b).

Fig. 8a. The post-irradiation reverse current as a function of the reverse voltage is shown for each beam run.

Fig. 8b. The post-irradiation forward current as a function of the forward voltage is shown for each beam run.

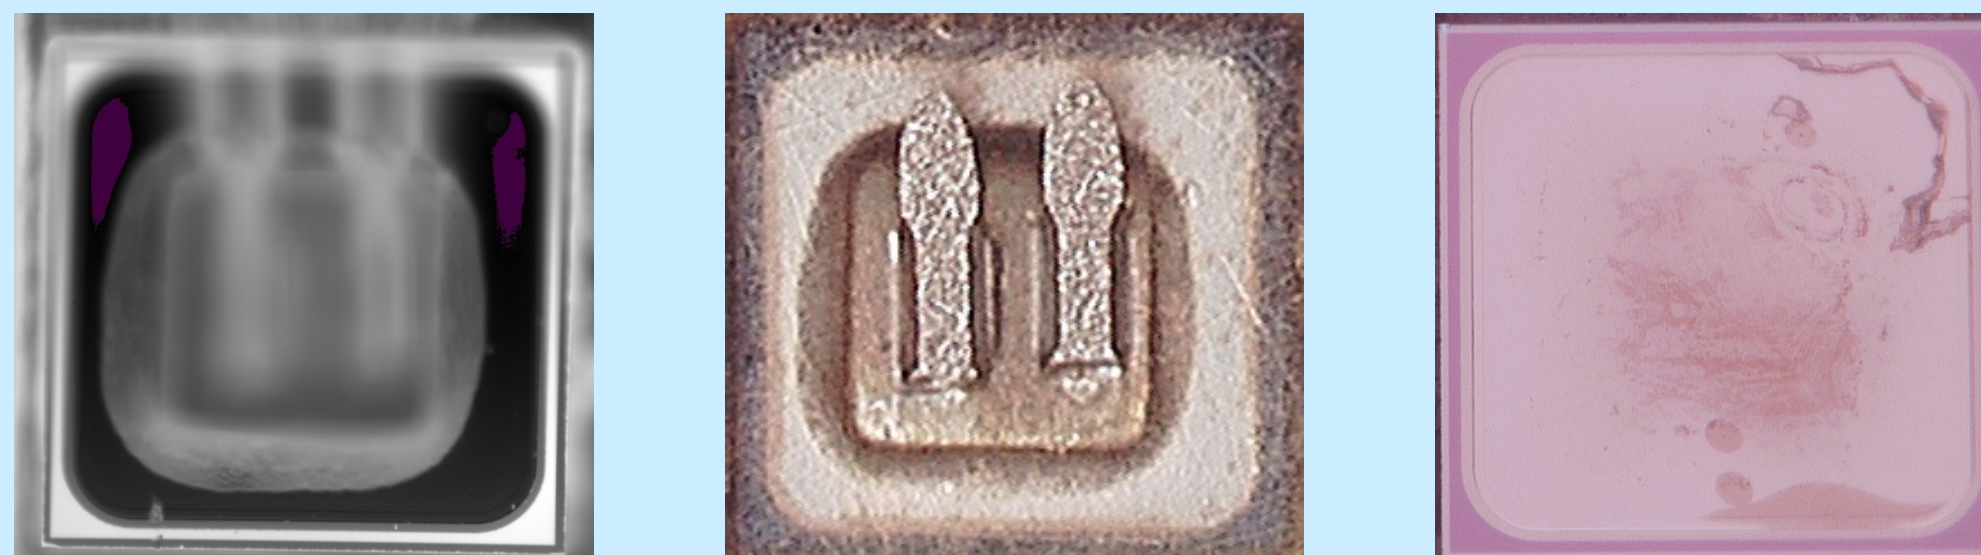
For SN2, even with 100 V applied, no failure locations were observed in the IR images (Fig. 9a), nor were any observed in the low-magnification optical images (Fig. 9b).

A different approach was then taken, where the bond wires, bond pad, and Schottky barrier metal were chemically etched and removed (Fig. 9c). On the surface of the silicon, a few discolorations were observed (Fig. 9d) and an SEM of two of the discolorations, and under high-magnification, a fused particle, which was later determined to be silicon, was observed in the center of the discolorations (Fig. 9e).

Fig. 9a. Thermal image of the irradiated SN2 does not identify any failure locations.

Fig. 9b. No failure location is visible in the low-magnification optical image of the DUT.

Fig. 9c. Three discolorations are observed in the silicon of SN2 after the Schottky barrier metal, bond pad, and bond wires were removed.

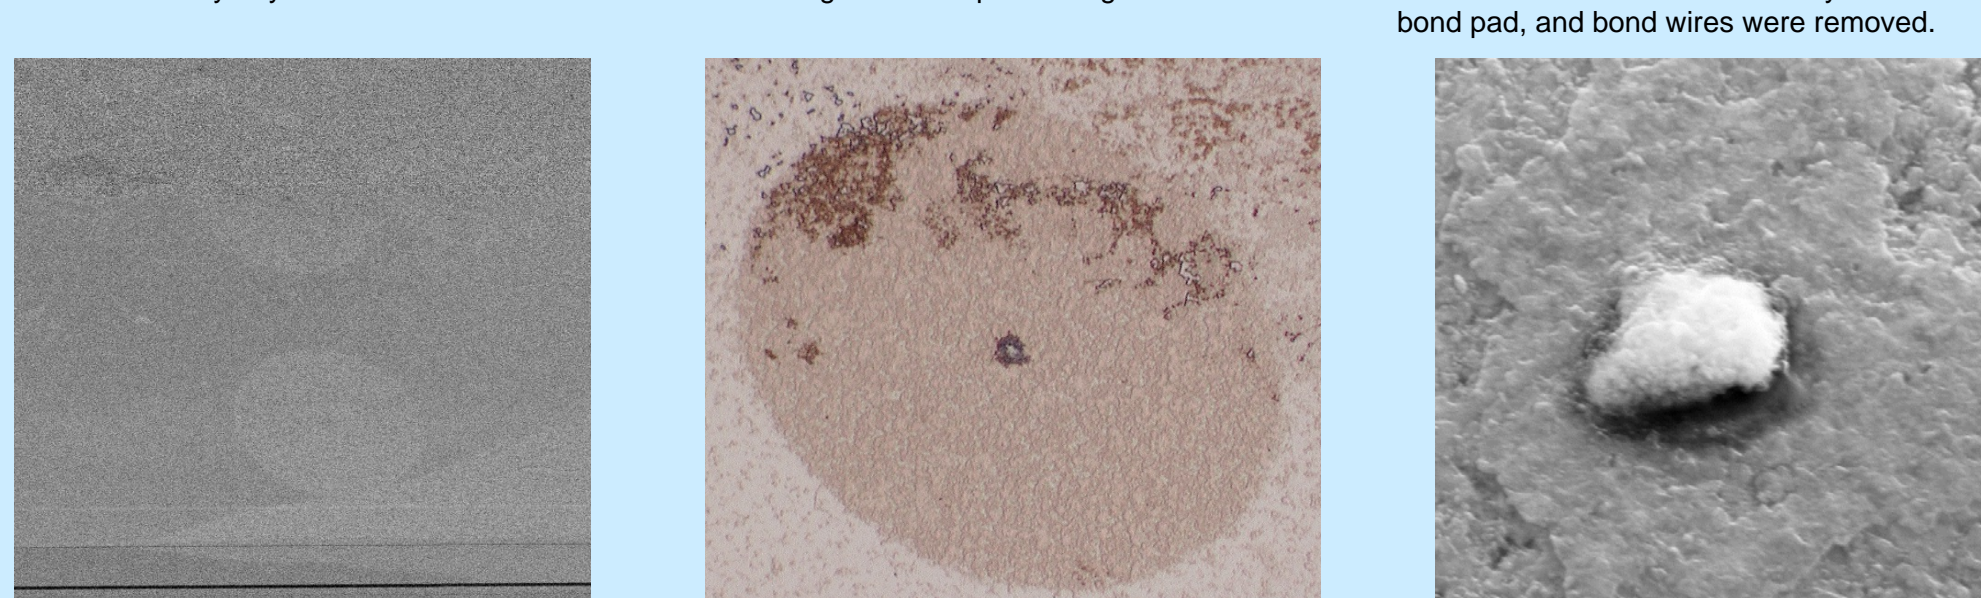
The silicon particles (Fig. 9f) are roughly 1 μ m across at the widest point.

Fig. 9d. SEM image of two of the discolorations observed on the surface of SN2.

Fig. 9e. High-magnification optical image of one of the discolorations observed on the surface of SN2.

Fig. 9f. SEM image of displaced silicon particle located at center of discoloration.

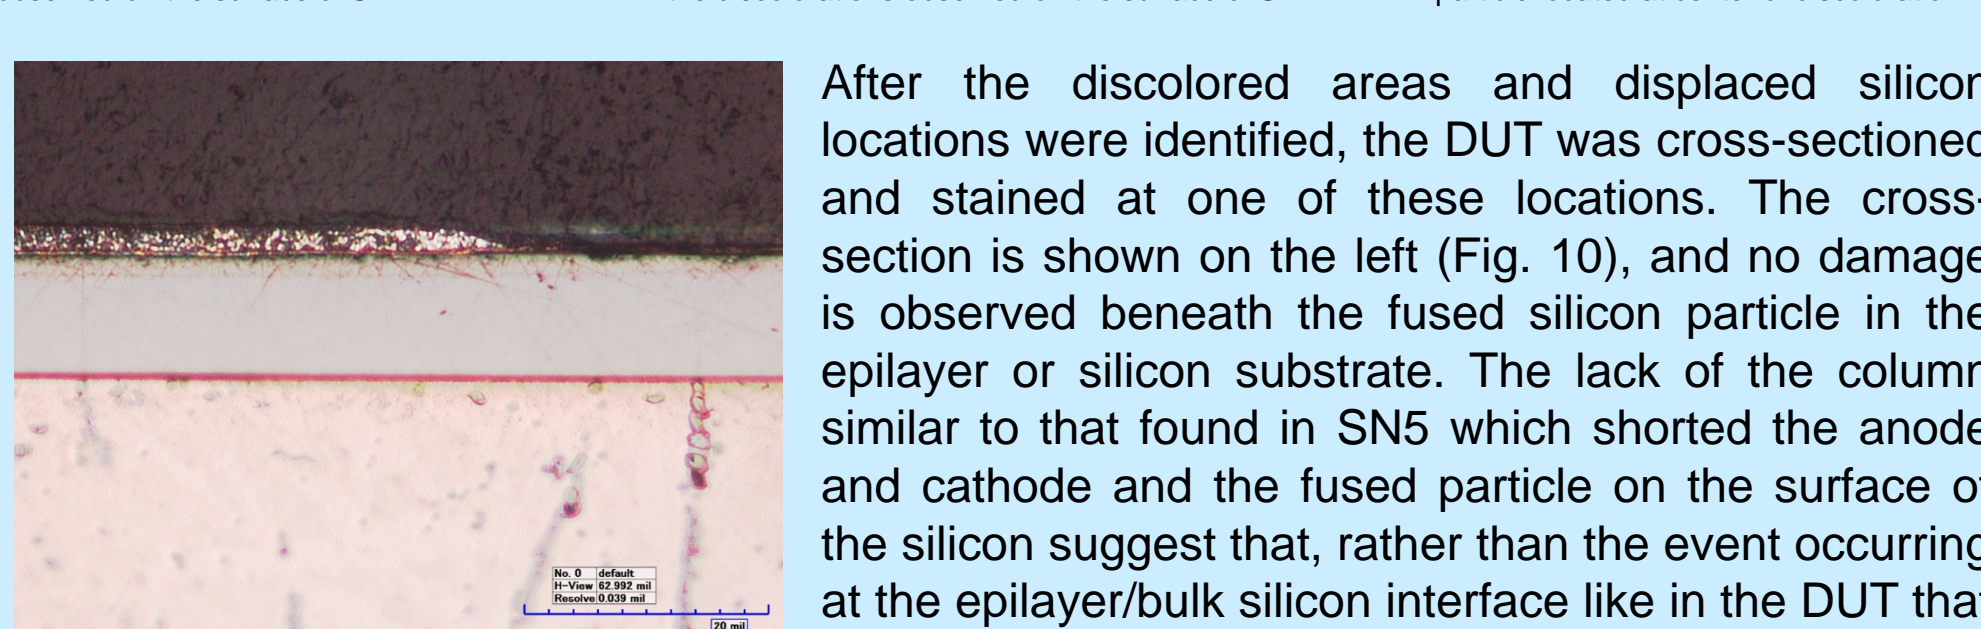
Fig. 10. The DUT was cross-sectioned through one of the discolored areas. No damage structure is present into the epilayer or bulk silicon.

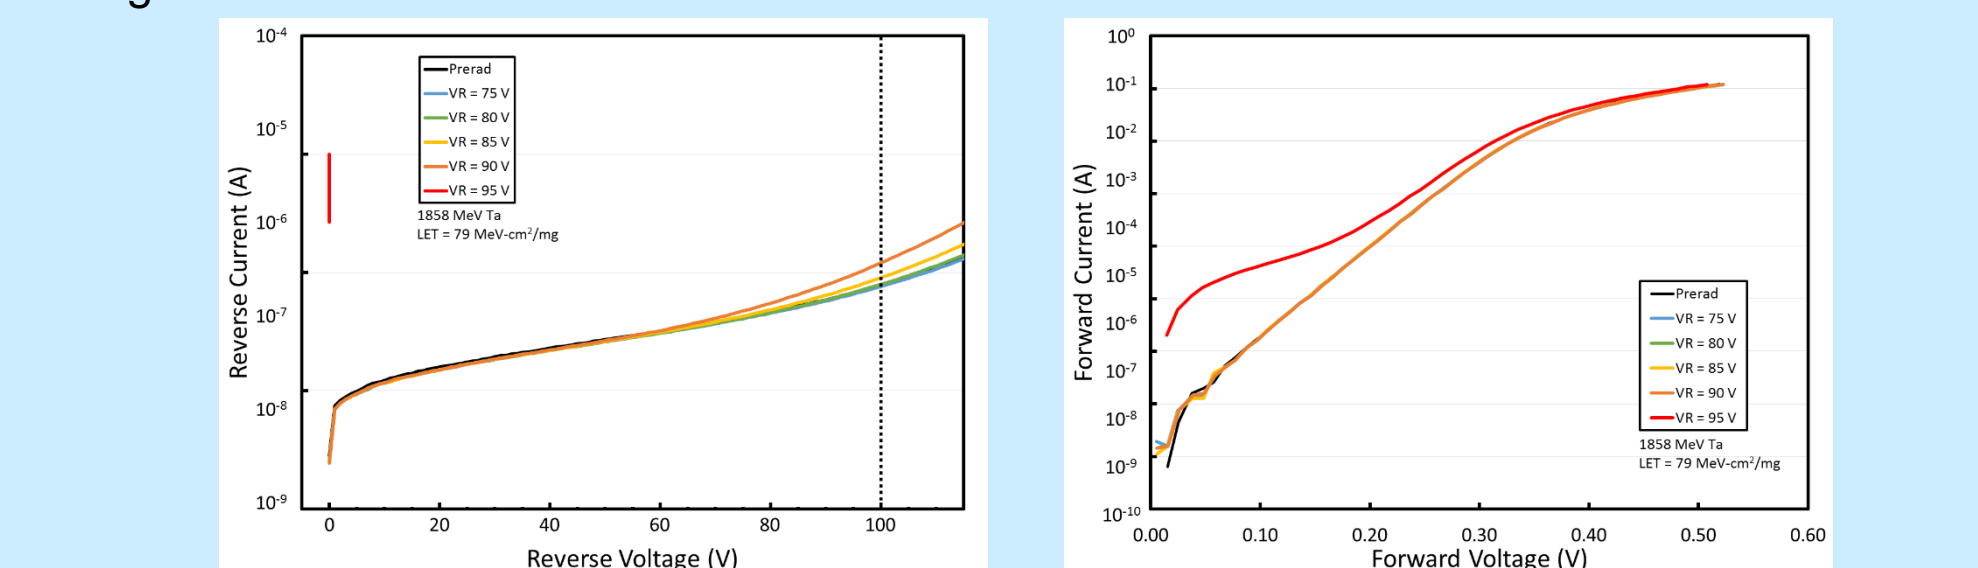
Almost no degradation was observed in the reverse I-V curve (Fig. 12a) until the 95-V run when I_R exceeded the 10 μ A specification at less than 1 V. Like with SN5, there was a significant change in the forward I-V curve (Fig. 12b) after the failing run.

Fig. 12a. The post-irradiation reverse current as a function of the reverse voltage is shown for each beam run.

Fig. 12b. The post-irradiation forward current as a function of the forward voltage is shown for each beam run.

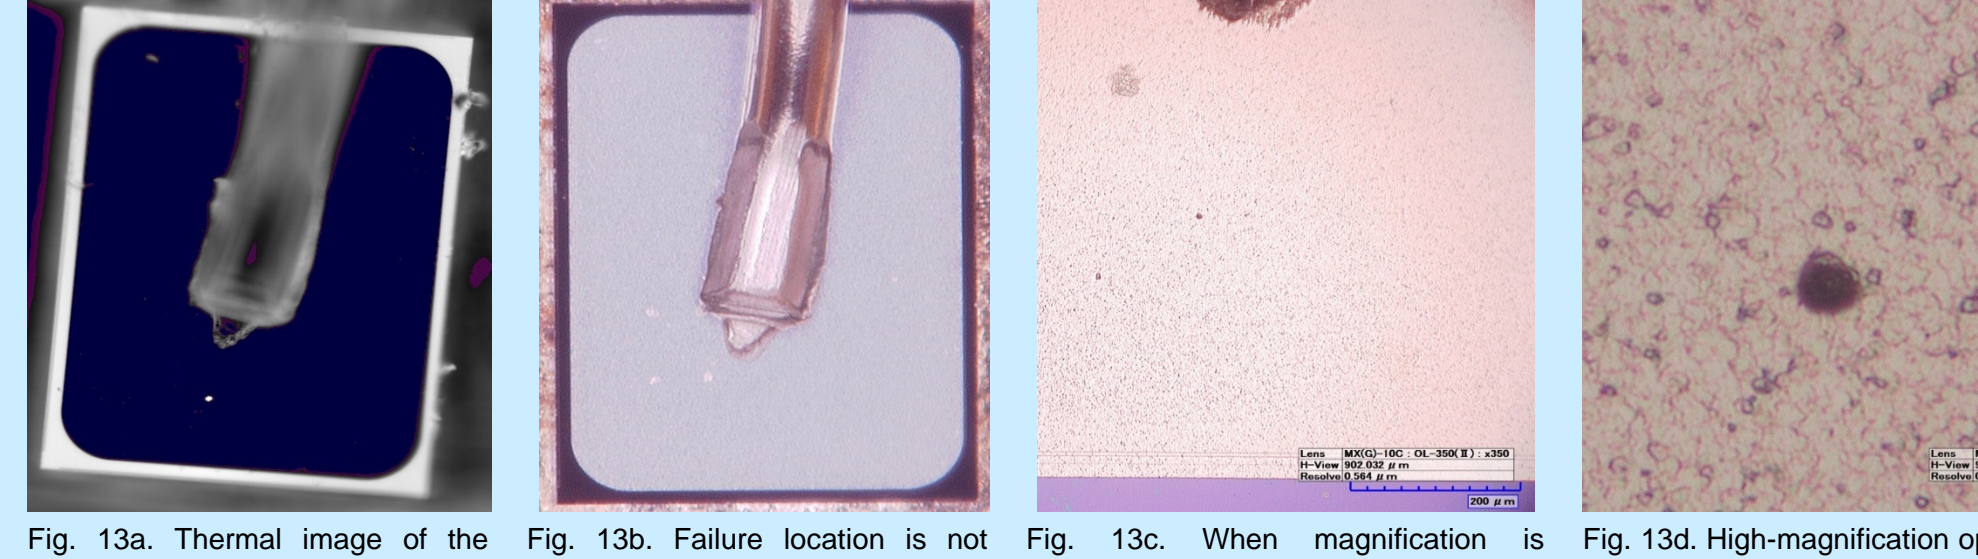
Using the thermal camera and a small applied voltage, the failure location was again visible in this DUT (Fig. 13a). When examined in the low-magnification optical image, the failure was not visible (Fig. 13b); however, when the magnification was increased, a dark spot could be seen (Figs. 13c and 13d). When that spot was investigated further with the SEM (Figs. 13e and 13f), it was clear that the Schottky barrier metal melted. Then, EDS showed (Fig. 13g) that not only had the metal melted, but silicon became displaced to the surface of the diode.

Fig. 13a. Thermal image of the irradiated DUT identifies location of failure.

Fig. 13b. Failure location is not visible in low-magnification optical image.

Fig. 13c. When magnification is increased, failure location is visible as a dark spot in optical images.

Fig. 13d. High-magnification optical image of the failure location observed in the IR image.

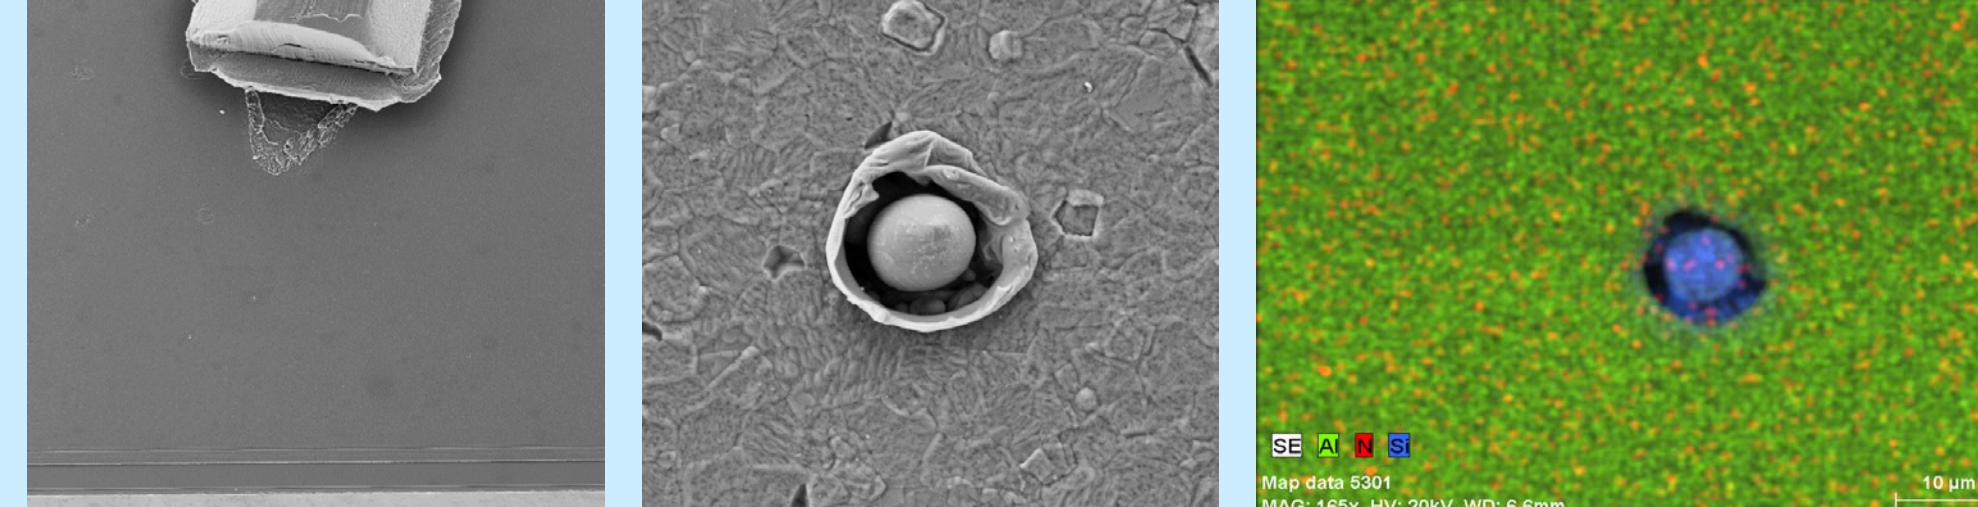
Fig. 13e. SEM image of the surface of SN7. Failure location is visible below the bondwire.

Fig. 13f. High-magnification SEM image of failure location.

Fig. 13g. Element map generated from EDS shows the Schottky barrier metal had melted away and silicon ball became displaced to the surface.

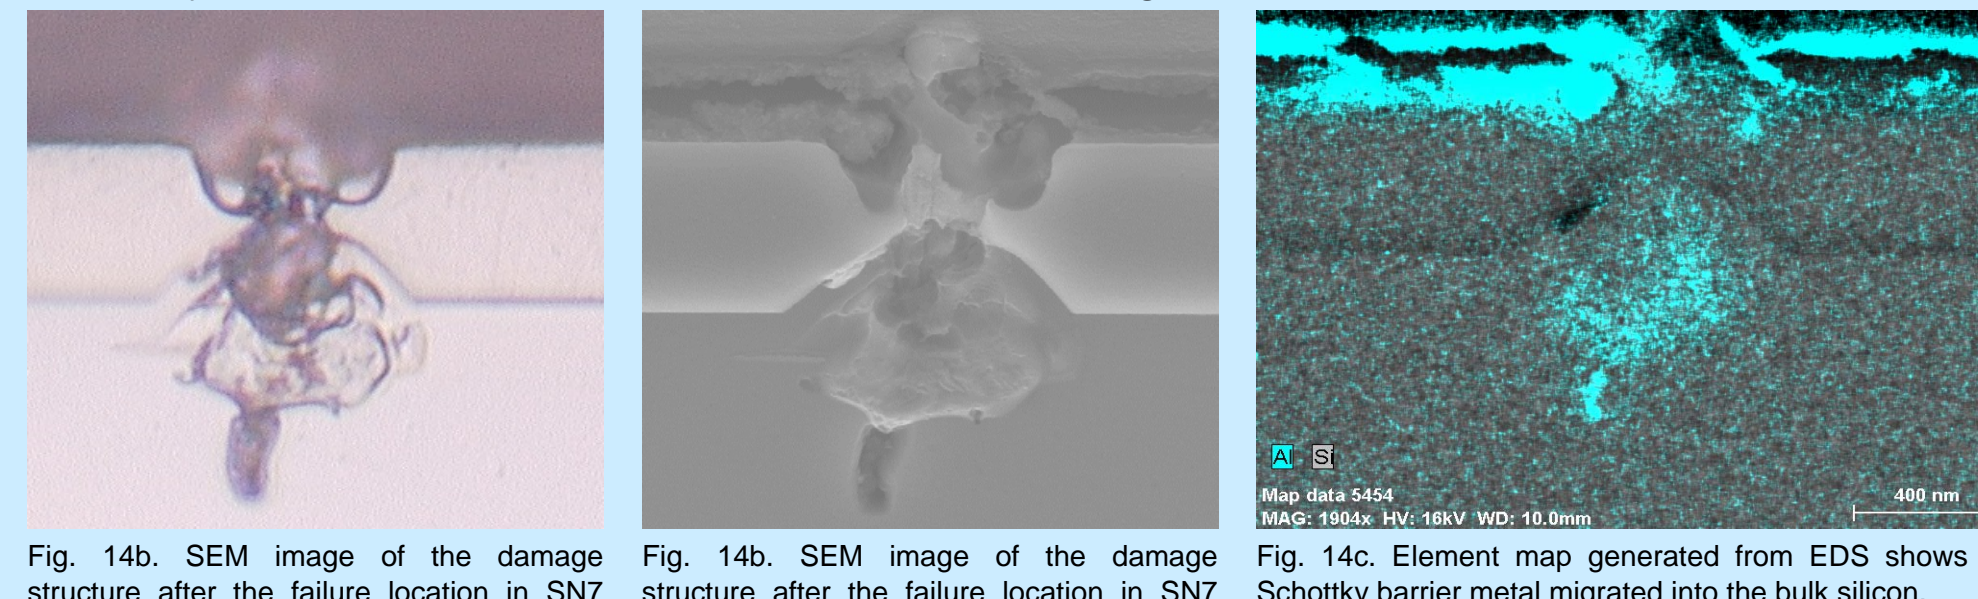
After identifying a failure location, SN7 was cross-sectioned at that location and stained (Fig. 14a). Like SN5, a large void was created through the silicon with most of the event occurring at the epilayer/bulk silicon border (Fig. 14b). There was a considerable portion at the silicon/metal interface as well. When EDS was performed on the cross-section, it was clear that, in addition to the displaced silicon that could be seen on the surface, aluminum from the Schottky barrier metal flowed into the bulk silicon (Fig. 14c).

Fig. 14a. SEM image of the damage structure after the failure location in SN7 was cross-sectioned.

Fig. 14b. SEM image of the damage structure after the failure location in SN7 was cross-sectioned.

Fig. 14c. Element map generated from EDS shows the Schottky barrier metal migrated into the bulk silicon.

To avoid these radiation responses in which the diode is operating outside of the manufacturer's specifications, a reverse voltage derating of 50% is recommended when testing will not be conducted. If testing will be conducted on the flight diodes under the application-specific bias conditions, then a derating similar to power MOSFETs is recommended, in which the maximum reverse voltage that may be used is 75% of the last passing voltage.
